Town of Firestone, CO

Pavement Management Analysis Report

October 2014

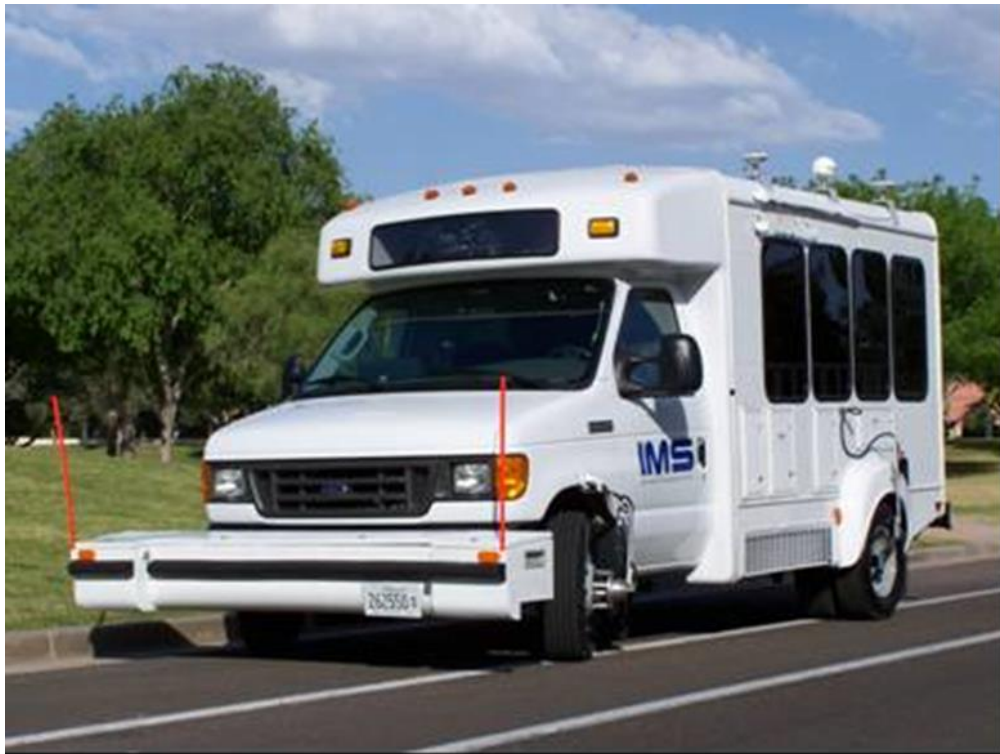
Laser Road Surface Tester (Laser RST)

- 2. Field Surveys** – Following a set of pre-defined assessment protocols matching the pavement management software (ASTM D6433), a specialized piece of survey equipment - referred to as a Laser Road Surface Tester (Laser RST, pictured on page 6), is used to collect observations on the condition of the pavement surface, as well as collect digital imagery and spatial coordinate information. The Laser RST surveys each street from end-to-end in a single pass, with arterial and collector roadways completed in two passes. In addition, a Dynaflect device was used to test the structural adequacy of roads.

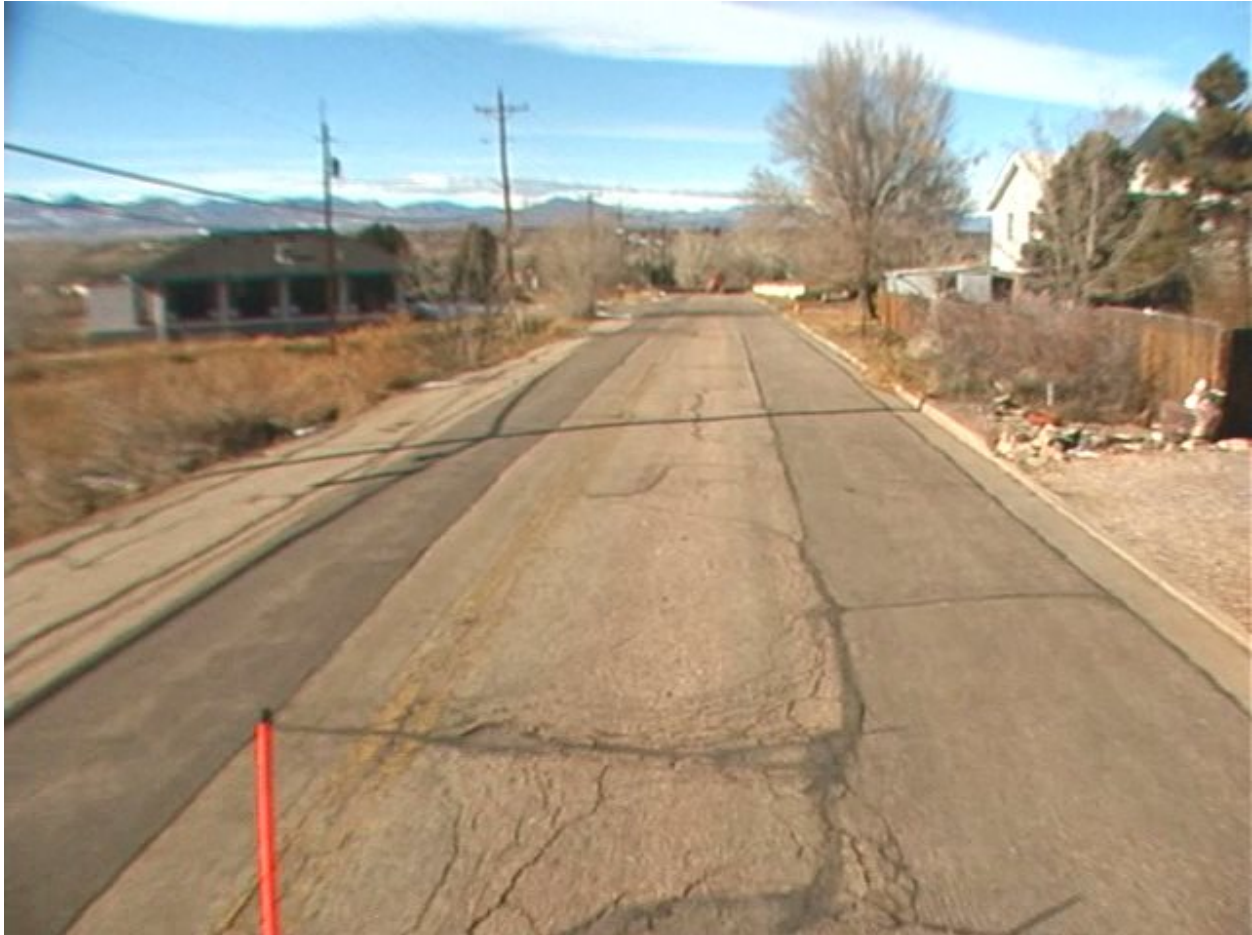
Very Poor (PCI = 0 to 25) – Complete Reconstruction

Ridge Rd. (Littleton, CO, PCI = 21) – As no road segments were determined to be very poor in Firestone, an example of a very poor street in Littleton, CO is shown above. Rated as very poor, this street displays extensive base failure as evidenced by the severe amount of fatigue (alligator) cracking and wheel path rutting. A mill and overlay on this street would not be suitable as the base has failed and would not meet an extended service life of at least 15 years.

Deferral of reconstruction of streets rated as very poor will not cause a substantial decrease in pavement quality as the streets have passed the opportunity for overlay based strategies. Due to the high cost of reconstruction, very poor streets are often deferred until full funding is available in favor of completing more streets that can be rehabilitated at lower costs, resulting in a greater net benefit to the town. This strategy however must be sensitive to citizen complaints forcing the street to be selected earlier. In addition, this type of street can pose a safety hazard for motorists, since severe potholes and distortions may develop. It is important to consistently monitor these streets and check for potholes or other structural deficiencies until the street is rebuilt.

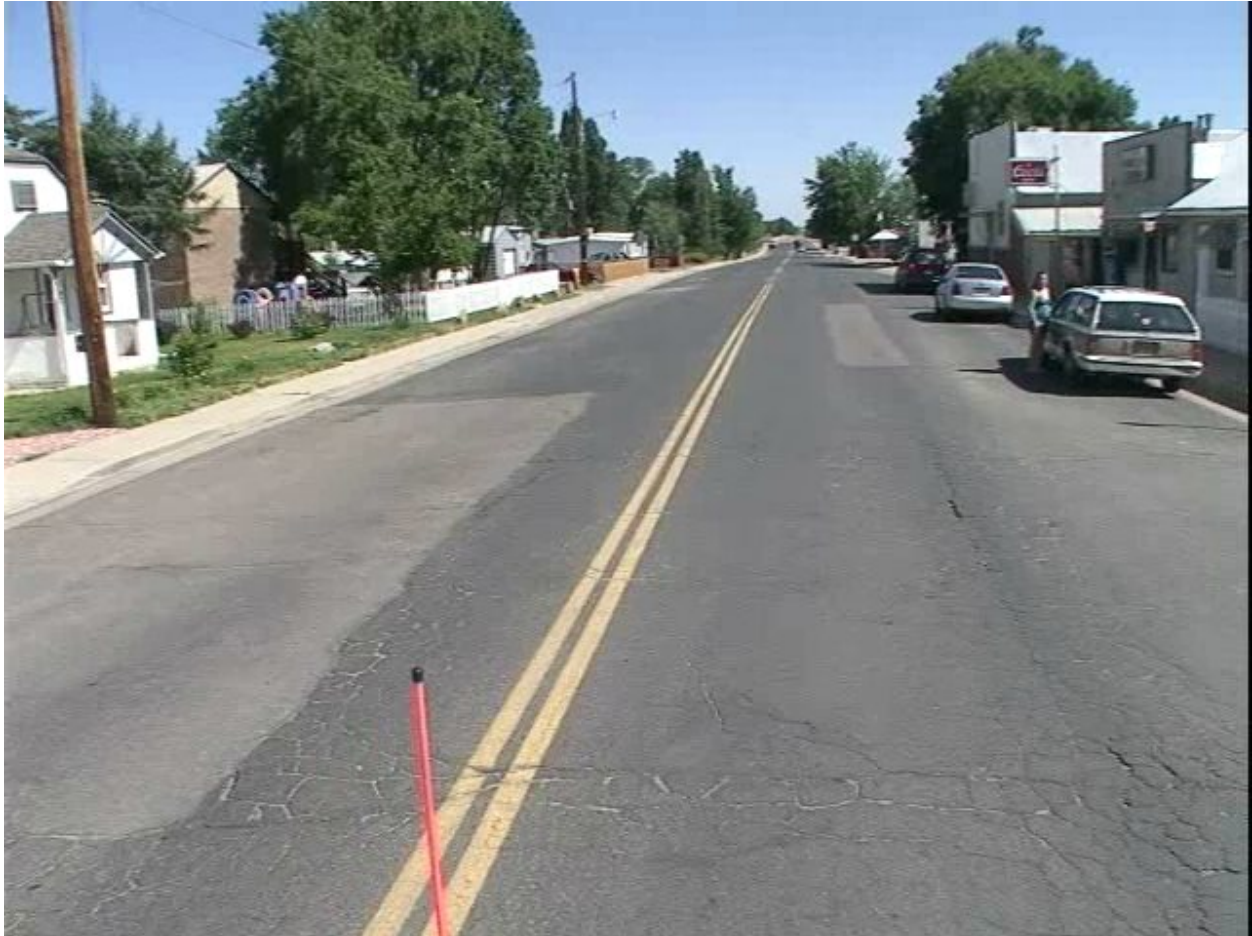
Poor (PCI = 25 to 40) – Last Opportunity for Surface Base Rehabilitation

1st Street Buchanan Ave. to Monmouth Ave. (GISID 5, PCI = 34) – Rated as Poor, this segment still has some remaining life before it becomes a critical reconstruction need. On this street, the base is starting to fail extensively and will continue to spread across the full width of the pavement. Some of the distresses present in this segment include linear & transverse cracking, alligator cracking, and rutting. However, if these areas were dug out and repaired, a mill and overlay would greatly extend the life of this roadway as the curb lines are in good condition and the base in reasonable condition.

On arterial roadways, poor streets require full reconstruction – that is removal of the pavement surface and base down to the subgrade and rebuilding from there. On local roadways, they require removal of the pavement surface through grinding or excavation, base repairs, restoration of the curb line and drainage, and then placement of a new surface.

In general, the service life of poor streets is such that if deferred for too long, it would require a more costly reconstruction. Streets rated as poor are typically selected first for rehabilitation as they provide the greatest cost benefit to the Town – that is the greatest increase in life per rehabilitation dollar spent.

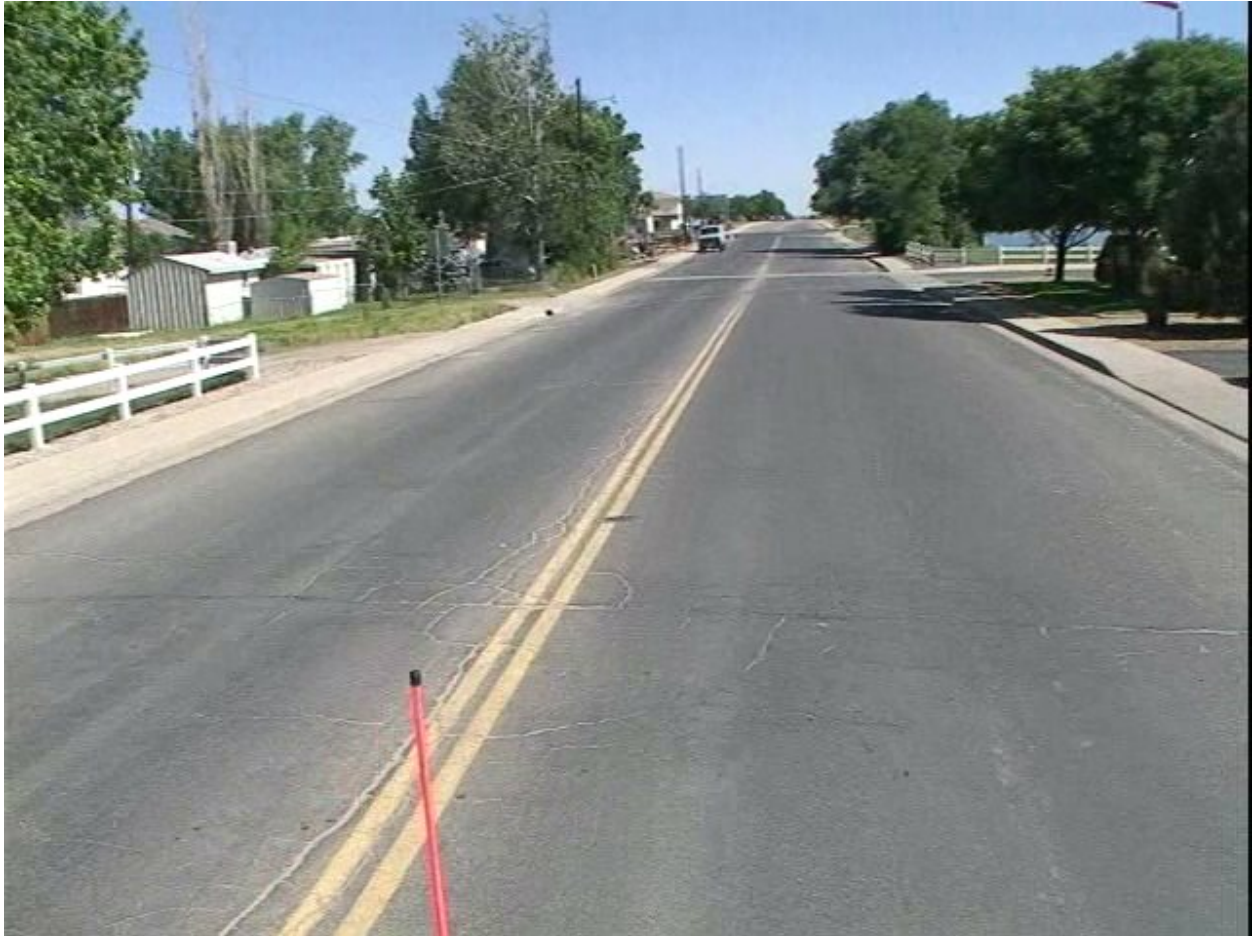
Marginal (PCI = 40 to 50) – Progressively Thicker Overlays, Often with Extensive Patching

1st Street from Jackson Dr. to Wooster Ave. (GISID 9 , PCI = 43) – Marginal streets have distresses that tend to be localized and moderate in nature – that is they do not extend the full length of the segment and can be readily dug out and repaired. This street segment highlights this characteristic as the failed area does not quite extend the full length or width of the roadway and is still serviceable. However, it also highlights the relationship between base and pavement quality. Placing an overlay on this street without repairing the base would not achieve a full 15 year life as the failure would continue to occur over time.

Similar to streets rated as poor, marginal streets that display high amounts of load associated distresses are selected as a priority for rehabilitation as they provide the greatest cost benefit to the Town – that is the greatest increase in life per rehabilitation dollar spent. If left untreated, marginal streets, with high amounts of load associated distresses would deteriorate to become partial reconstruction candidates. Marginal streets that are failing due to materials issues or non-load associated failures may become suitable candidates for thick overlays if deferred without a significant cost increase.

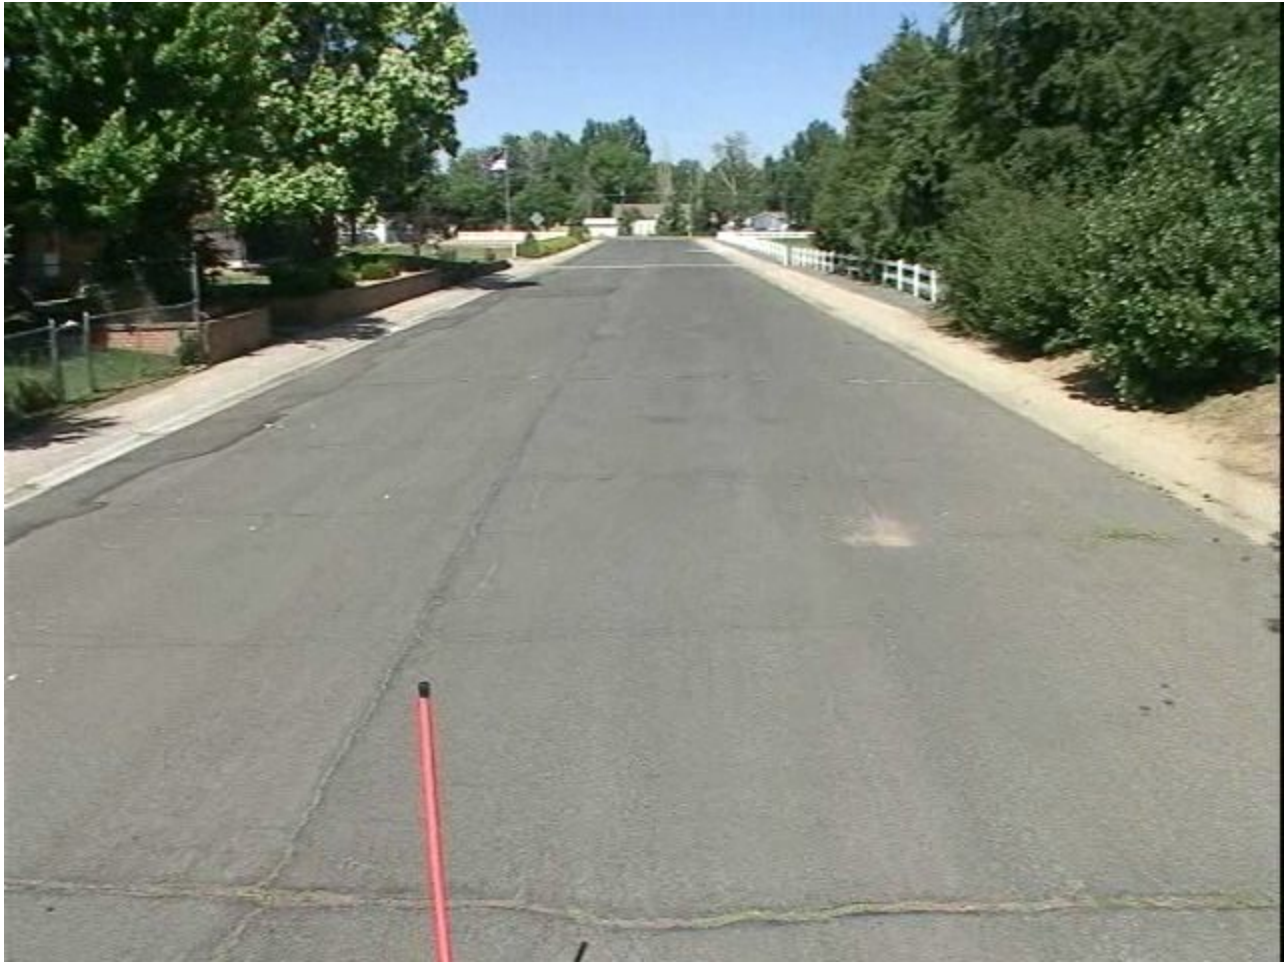
Fair (PCI = 50 to 60) – Thin to Moderate Overlays

Wooster Ave. from 1st Street to 2nd Street (GISID 567, PCI = 57) – rated in the Fair category, requiring thin to moderate overlays for asphalt and slab replacements for concrete when they enter their need year (generally within 2-3 points of the lower PCI in the defined range). Several distresses are present, but tend to be more localized and moderate in severity, and non-load related (primarily transverse shrinkage cracks). Asphalt streets rated as fair tend to receive a lower priority when developing a rehabilitation program. The reason for this is the cost to complete an overlay now would be on the order of \$11 to \$19/yd² depending on the functional classification. If deferred, the rehabilitation cost would only increase by about \$3 to \$6/yd² in about 5 to 10 years. Thus, the cost of deferral is low when compared to deferring a thick overlay to a reconstruction with a two to threefold increase in cost. Rehabilitation of concrete roads has limited options as it is difficult to complete surface based overlays. Rehabilitation strategies tend to focus on removal and replacement of whole or partial slabs and surface grinding to restore the longitudinal profile of the roadway.

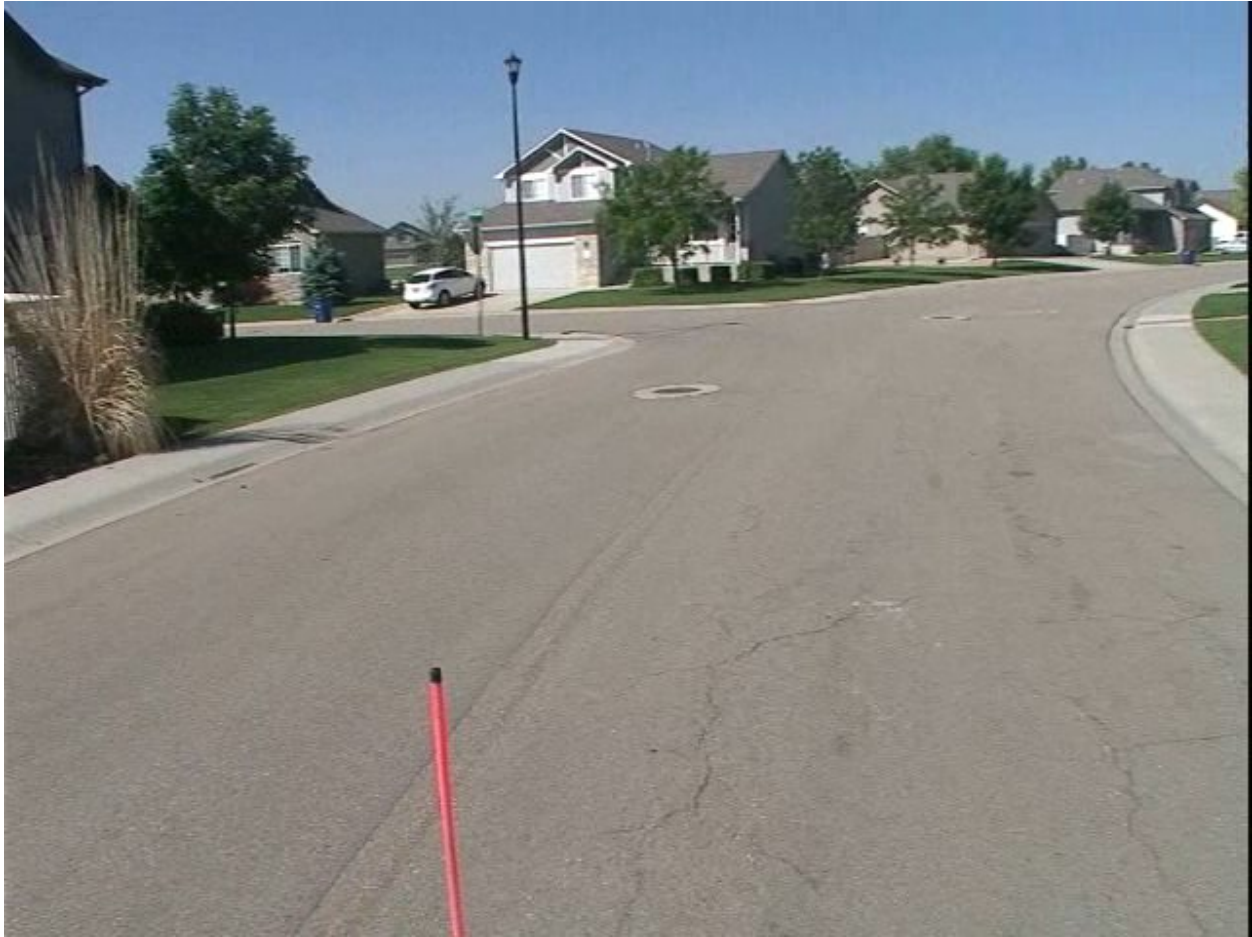
Good (PCI = 60 to 70) – Surface Treatments to Thin Overlays

Ruby Ave. from Cascade St. to Bluegrass St. (GISID 430, PCI = 68) – rated as Good, it displays small amounts of distresses that can easily be removed, replaced, and covered to restore the visual appearance of the roadway.

Streets rated as good are ideal candidates for thinner surface based rehabilitations and local repairs. Depending on the amount of localized failures, a thin edge mill and overlay, or possibly a surface treatment, would be a suitable rehabilitation strategy for streets rated as good. Streets that fall in the high 60 – low 70 PCI range provide the greatest opportunity for extending pavement life at the lowest possible cost, thus applying the principals of the perpetual life cycle approach to pavement maintenance.

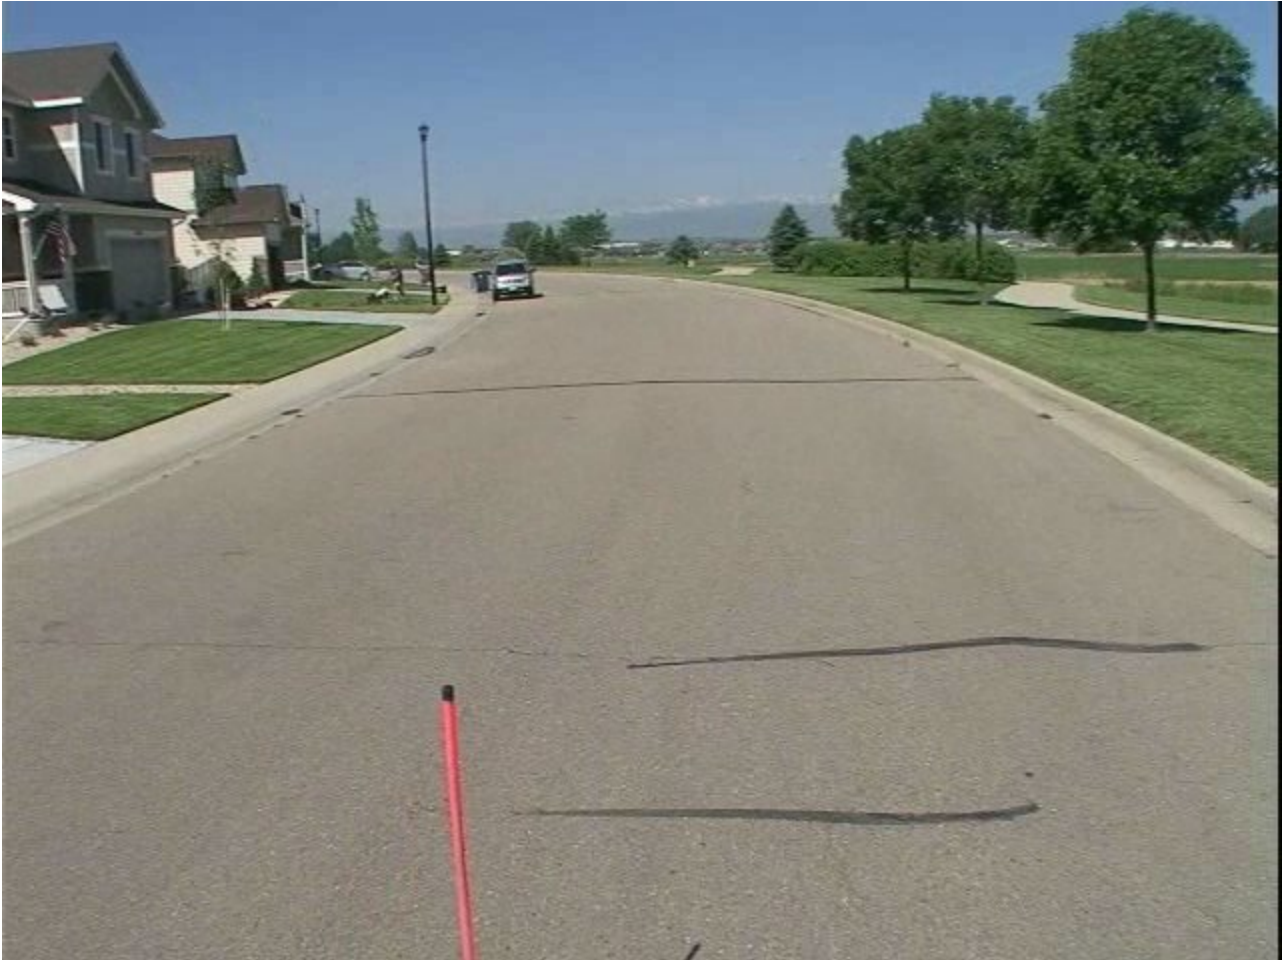
Very Good (PCI = 70 to 85) – Surface Treatments and Routine Maintenance

McClure Ave. from Farmdale St. to Forest St. (GISID 387, PCI =79) – rated as Very Good, displaying minor amounts of cracking that are localized and in good condition (this is about the worst part of the street). The ride is smooth, the surface is non-weathered, and the base is still strong.

Streets rated as very good generally need lightweight surface based treatments such as surface seals, slurries, chip seals or micro surfacing. Routine maintenance such as crack sealing and localized repairs often precede surface treatments. The concept is to keep the cracks as waterproof as possible through crack sealing and the application of a surface treatment. By keeping water out of the base layers, the pavement life is extended without the need for thicker rehabilitations such as overlays or reconstruction. Surface treatments also tend to increase surface friction and visual appearance of the pavement surface but do not add structure or increase smoothness. Surface treatments may include:

- Double or single application of slurry seals (slurries are a sand and asphalt cement mix).
- Micro surfacing – asphalt cement and up to 3/8 sand aggregate.
- Chip seals and Cape seals (Chip seal followed by a slurry)

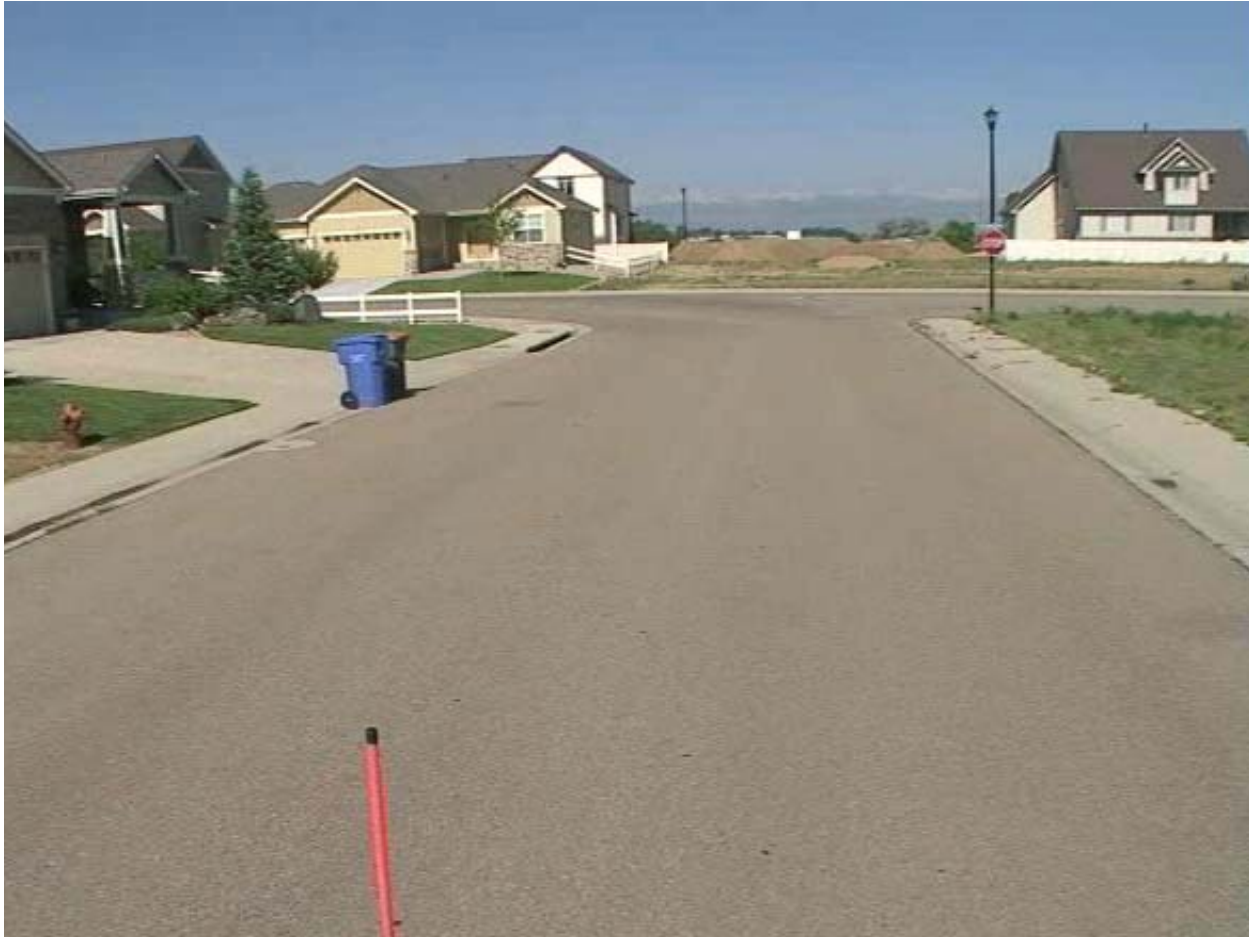
Excellent (PCI = 85 to 100)

Sage Ave. from Devonshire St. to Dogwood St. (GISID 334, PCI = 87) - rated as *Excellent*, displaying little to no surface distresses. The ride is smooth and the surface is non-weathered and the base is still strong. In a couple of years, this street segment would be an ideal candidate for routine maintenance activities such as crack sealing.
